Circular 66 / 2013

Subject: *IMPORTANT* Complying with the IMSBC Code

FLYER TO THE SHIPPING INDUSTRY

Catastrophic structural failure of a general cargo ship

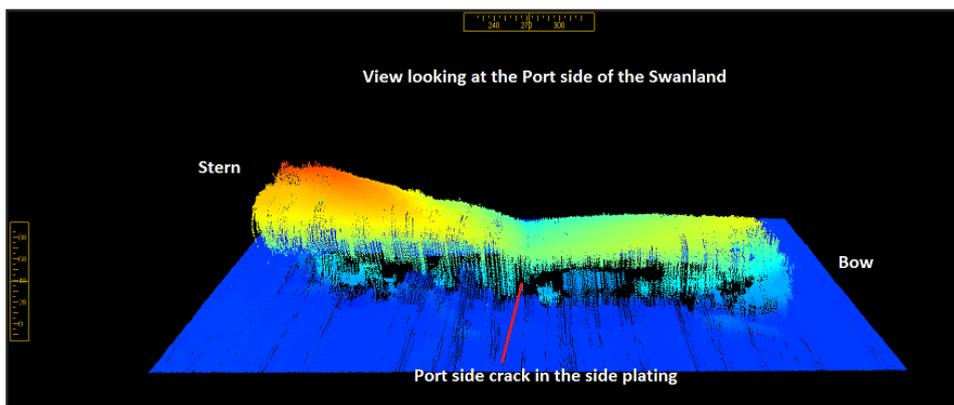
Figure 1: Sonar image of *Swanland* inverted on the seabed

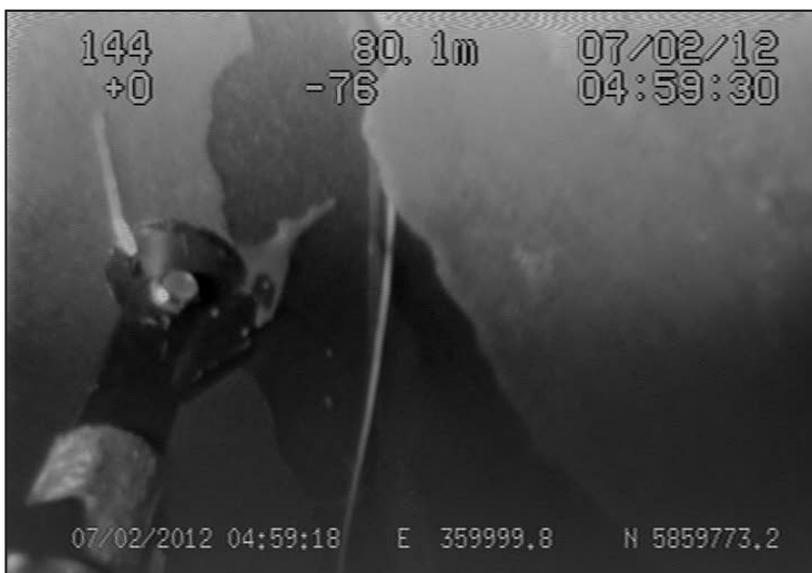
On 27 November 2011, the master and five of the crew from the 34-year old general cargo ship *Swanland* were lost when the vessel foundered about 17 minutes after suffering a structural failure amidships. The failure occurred as the vessel was heading directly into a south westerly gale in rough to very rough seas. Only the second officer and an AB survived. Underwater surveys confirmed that the vessel had suffered a structural failure amidships (**Figure 2**).

Figure 2: ROV image of the structural failure amidships

A longitudinal strength assessment of the vessel following the accident confirmed that the large sagging bending moments induced by the cargo and the wave conditions experienced on the day of the accident would have been sufficient to cause compressive failure of the upper midships structure.

Swanland's foundering is one of many cargo ship losses in recent years in which poor loading or overloading of cargo has been a significant contributing factor. In this case, the stresses on the vessel's hull would have been significantly reduced had the limestone cargo been loaded and trimmed in an even or more 'homogenous' distribution within the vessel's single hold.

- Adhere to the requirements and best practice contained in SOLAS and the IMSBC Code, particularly regarding:
 - The provision of sufficient information on a vessel's longitudinal and tank top strengths and the proper distribution of the cargo in order to prevent the structure from being overstressed.
 - The importance of cargo trimming; a single pile of cargo will inevitably lead to increased bending moments and might also overload the tank tops in the cargo hold.
- Ensure that appropriate authorisation to carry solid bulk and high density cargoes has been obtained from the vessel's flag state administration and/or classification society.
- Where possible, reduce the wave-induced bending moments and stresses on a vessel's structure in heavy weather by weather routing, sheltering, or adjusting course and/or speed.

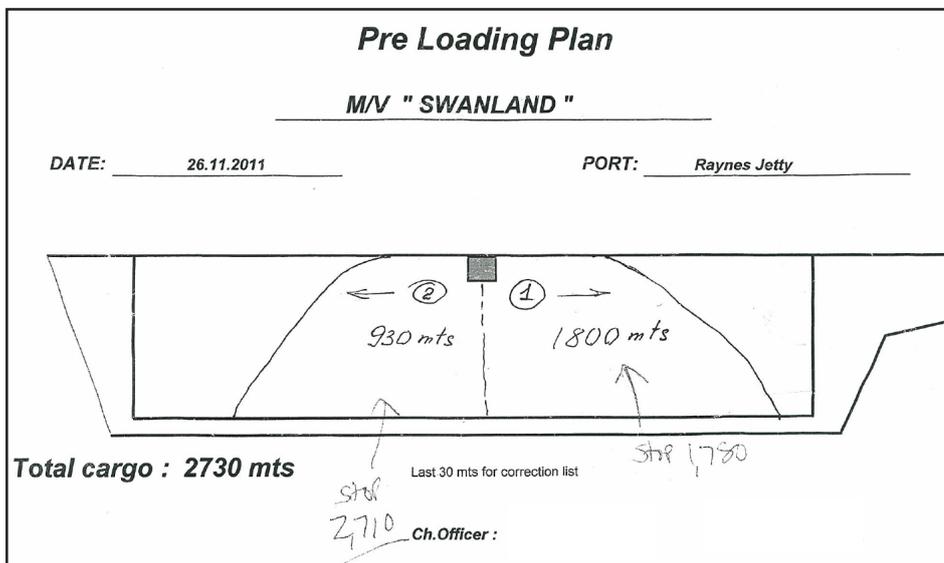
At the time of the accident, *Swanland* was carrying a cargo of 2730 tonnes of MOT Type 1 Granular Sub Base (GSB) limestone, which is a high density cargo. The limestone had been loaded in two piles biased towards the centre of the vessel's single hold in accordance with the loading plan prepared on board (**Figure 3**).

The vessel had been converted in 2003 to allow self-discharging of the cargo and had carried limestone in this manner on numerous occasions. The loading information available on board *Swanland* was probably limited to that included in the vessel's stability book, which lacked detail and provided no information on longitudinal strength or tank top loading limits. *Swanland* had not been strengthened to carry heavy cargoes.

Figure 3: Pre-loading plan

- By providing cargo information, including density and angle of repose, to a vessel's master or his representatives.
- By agreeing with a master how a solid bulk cargo is to be loaded or unloaded to ensure that the permissible forces and moments on the ship are not exceeded.
