Circular 18 / 2010**To: All Shipowners, Managers, Lifeboat Manufacturers and Lifeboat Maintenance Service Providers, Deputy Registrars, Surveyors and Other Interested Parties****Subject: Lifeboats – Fixed Structural Connections of Release Mechanisms****Date: 13 May 2010**

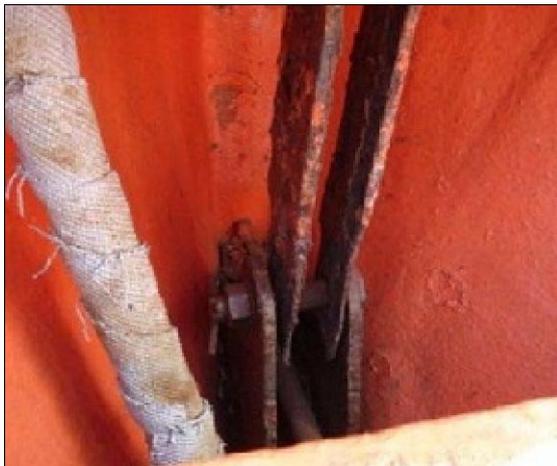
SOLAS Chapter III, Regulation 20.3 requires maintenance, testing and inspections to be carried out in a manner which will ensure the reliability of lifesaving and launching appliances. Regulations 20.6, 20.7 and 20.11 require shipowners' representatives to conduct weekly, monthly and annual examinations of lifesaving appliances and launching appliances to confirm that they are fit for purpose. There is a requirement to check the condition of lifeboat structure, which includes the condition of the fixed structural connections of lifeboat release mechanisms, and our records show that this area can be prone to wastage, as the photograph below illustrates.

It is recommended that, at weekly, monthly and annual examinations, particular attention is paid to the following:

- Are the lifting straps wasted?
- Is there evidence of the fixing bolts moving in the foundation plates?
- Is there evidence of surface cracking in the GRP laminate?
- Do the release hook foundation plates remain a good fit and will they prevent the ingress of water under the fitting?
- Is there discolouration of the GRP structure in the areas around fixings?

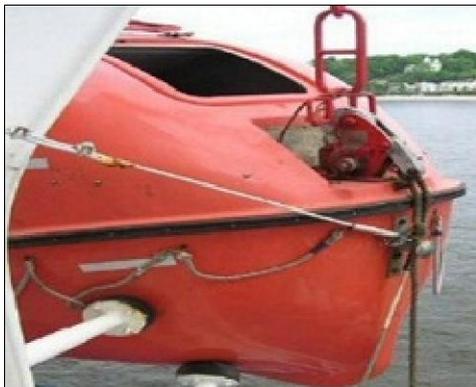
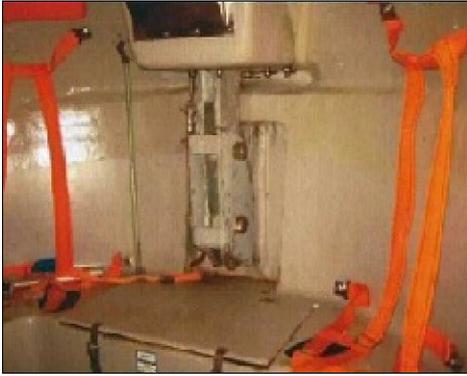
In addition, we are increasingly seeing fixed structural connections where the forward release hook mechanism is attached to the lifeboat stem. In these cases, a pedestal is attached to the release hook foundation plate for the gripping wire. There has been a recent example of this type of connection failing in service due to a number of factors, including mechanical damage and poor maintenance. Examples of external and internal arrangements are pictured below.

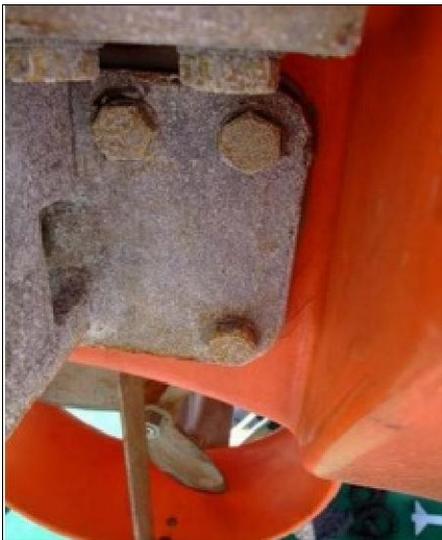
For freefall lifeboats, the area around the release hook should also be checked for damage. The photograph below shows how damage to the lifeboat has caused cracking of the GRP.
