## TECHNICAL CIRCULAR 182/2018

**Subject:** Life saving appliances (LSAs), Fire fighting equipment (FFEs) and detection systems.

**Applicability:** All commercial yachts, irrespective of the Gross Tonnage.

## *Summary of Investigation Findings*

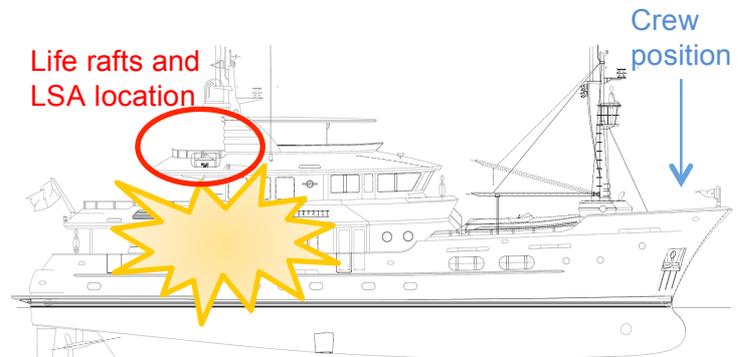
During the abandonment, both of the life rafts carried were not accessible due to the spread of the fire. The crew's impossibility to access the life rafts demonstrates **the disadvantages of siting all life rafts in a single location**, which is common practice for yacht of this size.

No crewmember was wearing individual lifesaving equipment, as all were located in the safety locker located at the aft end of the bridge deck close to the life rafts, which was already interested by the fire. No lifejackets were reportedly located in crew/guests cabins.

Item	Reference	Recommendatory measures
Life rafts	CI LYC 14.2.2 CI SYC 14.3	Not to be sited, as far as practicable, in a single location on-board the yacht.
Life rafts	CI LYC 14.2.2 CI SYC 14.3	To be transferrable in a longitudinal way, as far as practicable, in case they should be originally placed in way of a vertical high risk area (such as engine room).
Life rafts	CI LYC 14.2.2 CI SYC 14.3	In case a life raft should request a mean, such as a deck crane, in order to be transferred and/or launched, the subject crane is recommended to be powered by an emergency source (such as emergency generator, or batteries), or operating by gravity.
Life rafts	CI LYC 14.2.2 CI SYC 14.3	Passengers to be duly trained before any voyage starts,
