Circular 65 / 2013

Subject: *IMPORTANT* Increasing the chance of survival in abandon ship situations

FLYER TO THE SHIPPING INDUSTRY

Six crew lost as a general cargo ship founders

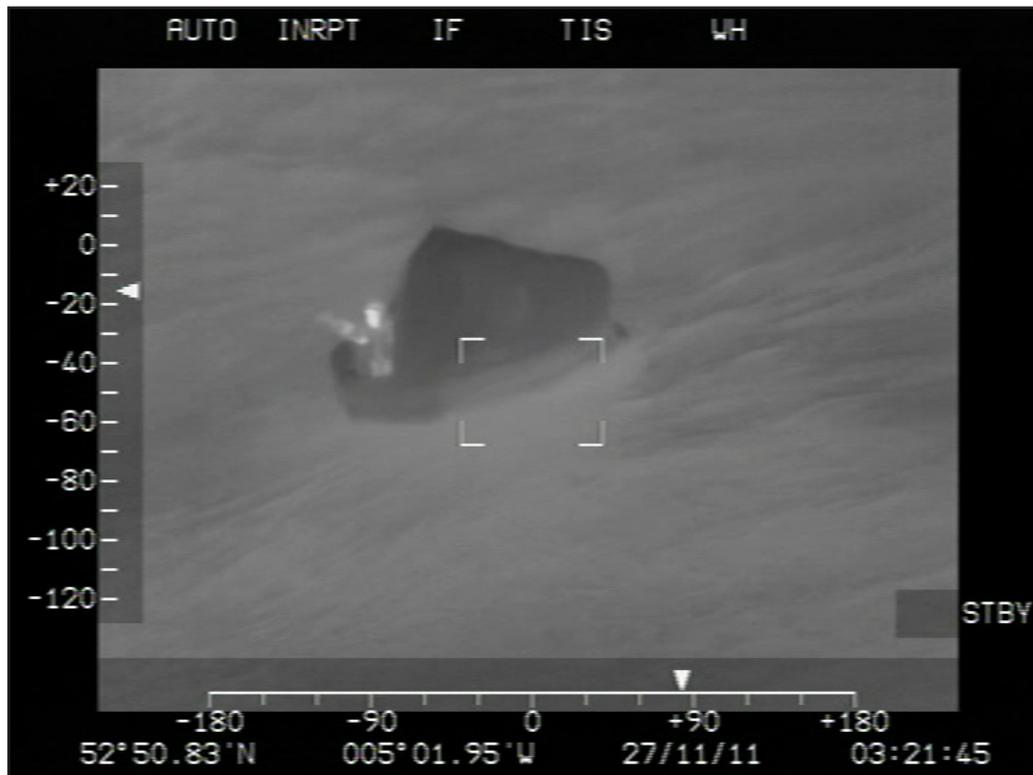
Swanland's two survivors in a liferaft

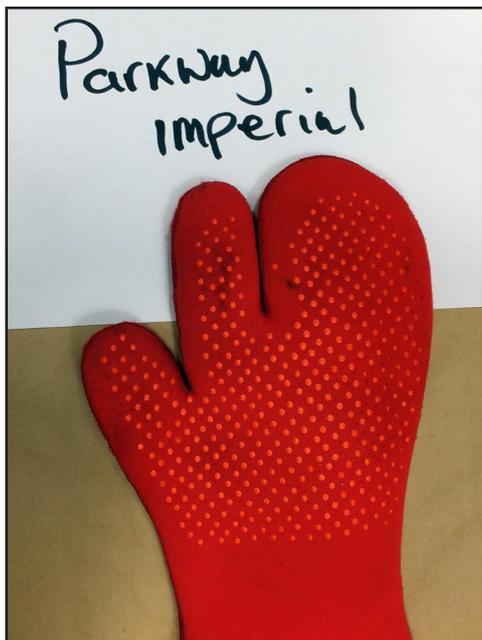
Figure 1: Immersion suit glove

As the vessel’s freeboard reduced, the master realised that the vessel was sinking and ordered the crew to prepare to launch the liferafts. At about the same time, the second officer collected the two search and rescue transponders (SART). However, he had difficulty activating them because of the design of the gloves integral to his immersion suit (**Figure 1**), and eventually had to use his teeth to operate them.

The liferaft's internal light soon extinguished, and the survivors continued to be hampered by the lack of dexterity afforded by the immersion suit gloves (**Figure 1**).

- The provision on board of several different types of immersion suit and lifejackets is potentially confusing and increases the risk of the equipment either being donned incorrectly or not quickly enough. It is commonsense that either all of the immersion suits provided on board a vessel should be of the same type; i.e. they all have in built buoyancy, or, they all need to be worn with a compatible lifejacket, but not a mix of the two designs. Even in large fleets that carry many types of suits and lifejackets, this can usually be arranged through good planning.

- The provision of LSA should be goal-based and holistic in order to ensure that the components are compatible and that the 'system' is fit for purpose. The compatibility of individual items of equipment cannot be taken for granted, even where the LSA provided meets the required performance standards.
