## TECHNICAL CIRCULAR 182/2018

**Subject:** Life saving appliances (LSAs), Fire fighting equipment (FFEs) and detection systems.

**Applicability:** All commercial yachts, irrespective of the Gross Tonnage.

## *Summary of Investigation Findings*

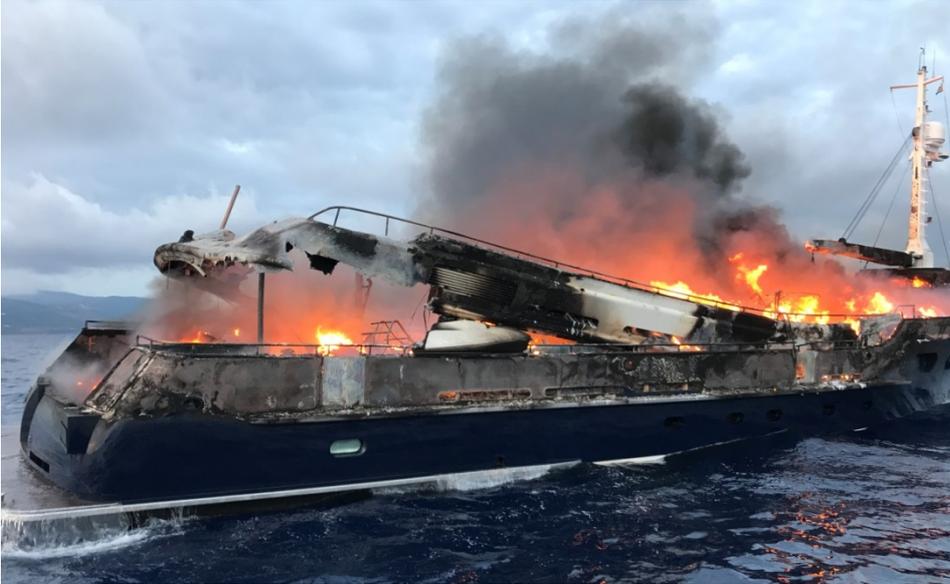
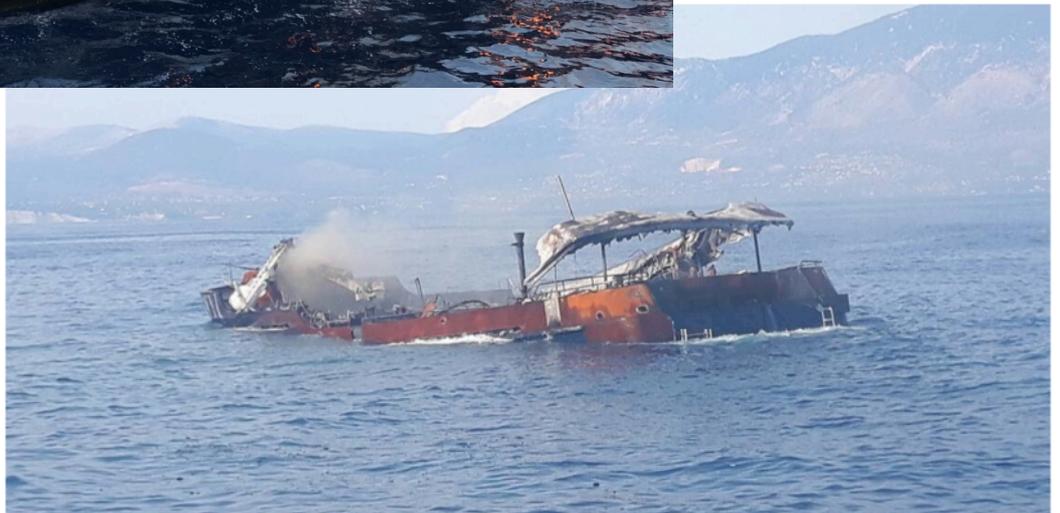
- The fire was probably caused by a short circuit to the underdeck lights in the aft lounge on the main deck.
- The spread of the fire was assisted by the airflow over the deck.

- During the abandoning, the crew did not wear individual LSAs as no lifejacket were located in crew/guest cabins.
- The fire was extinguished by a fire-rescue boat which reached the Cook Islands flagged yacht about four (4) hours after the fire was detected.

- The yacht foundered as a result of the large amount of water that accumulated in her hull during the fire-fighting effort.
